# Manhole Inspection Summary

Manhole # S37AA1030MH

**Location** Address: **3501 OLD YORK RD**

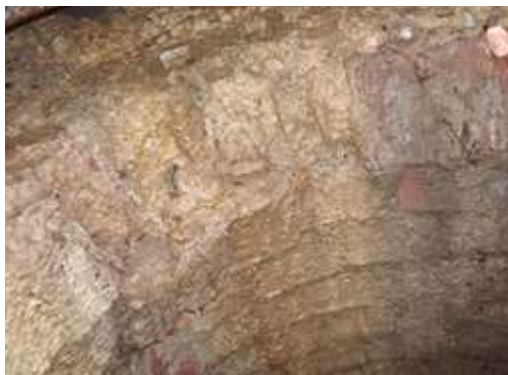
Defect

Adjustment deterioration and infiltration.

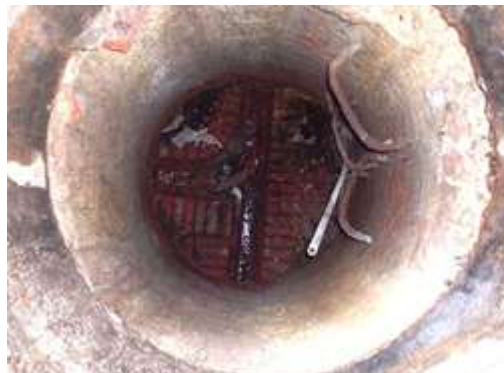
Top View

Frame leaks. Adjustment deterioration, loose brick and infiltration. Corroded steps. Evidence of surcharge - Bench debris.

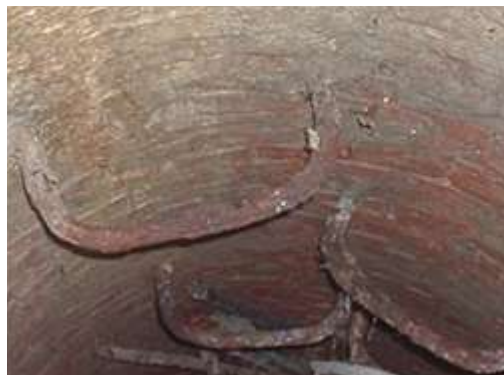
Defect

Adjustment and Barrel infiltration.

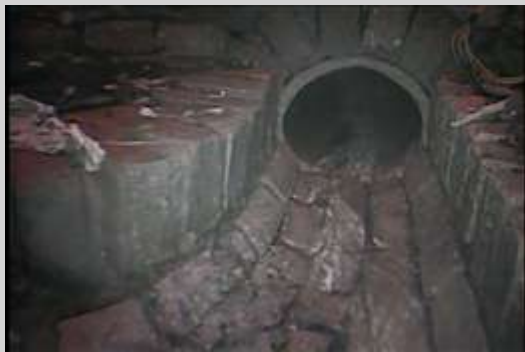
### 8 in. Circular Gravity Sewer Pipe Out @ 12 O'Clock

Channel deterioration.

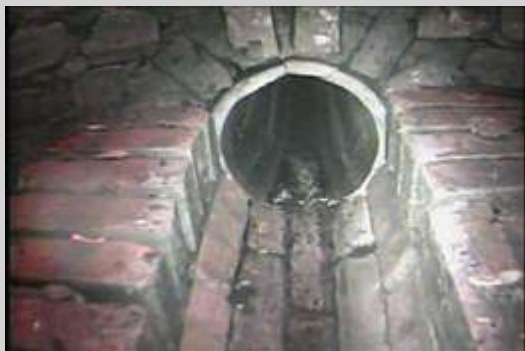
### 8 in. Circular Gravity Sewer Pipe In @ 6 O'Clock

Infiltration: **Evidence** Pipe Seal Cond: **Broken**

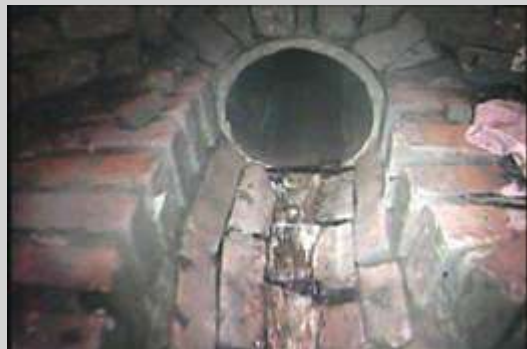
Pipe In @ 9 O'Clock

Channel and Bench deterioration.

Infiltration: **Evidence**

Pipe Seal Cond: **Cracked**
